## **Peat Landslide Hazard and Risk Assessment (PLHRA)**

## TA12.3 - Peat Landslide Hazard and Risk Assessment Shepherds' Rig Wind Farm

Dumfries & Galloway, Scotland  
Boralex

042251-D-001v02

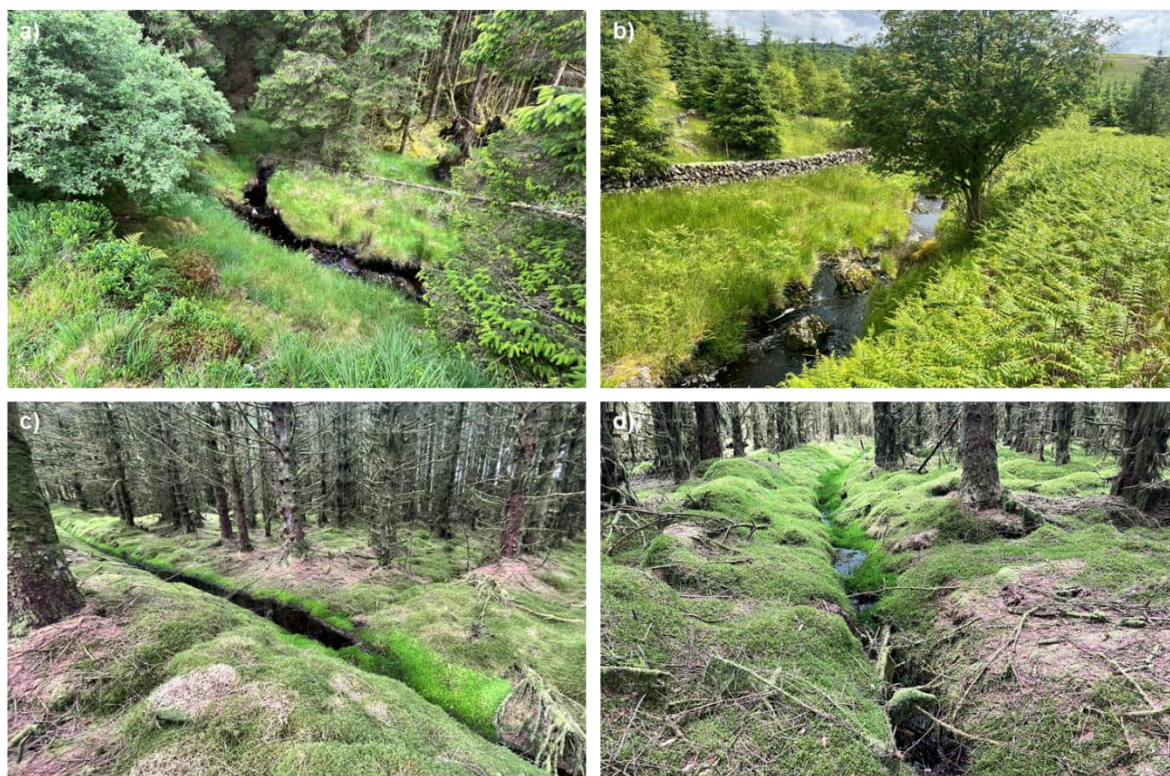
**Plate 3.2 a) Craigengillan Burn in its upper reaches, b) Craigengillan Burn in its lower reaches, c) a forest drain, self-blocked by roots and litter, d) a partially recovered drain**

In the south of the site, the lengthy and sinuous Black Burn flows from the saddle to join the Water of Ken directly, while further south, below Marscalloch Hill, Dry Burn is joined by an unnamed minor tributary before flowing into the Water of Ken around 2-3 km upstream of Kendoon Loch. Only two minor watercourses less than 0.5 km in length are present on the south side of Marscalloch Hill, both well away from infrastructure. Typical hydrological features are shown on Plates 3.2 a to d.

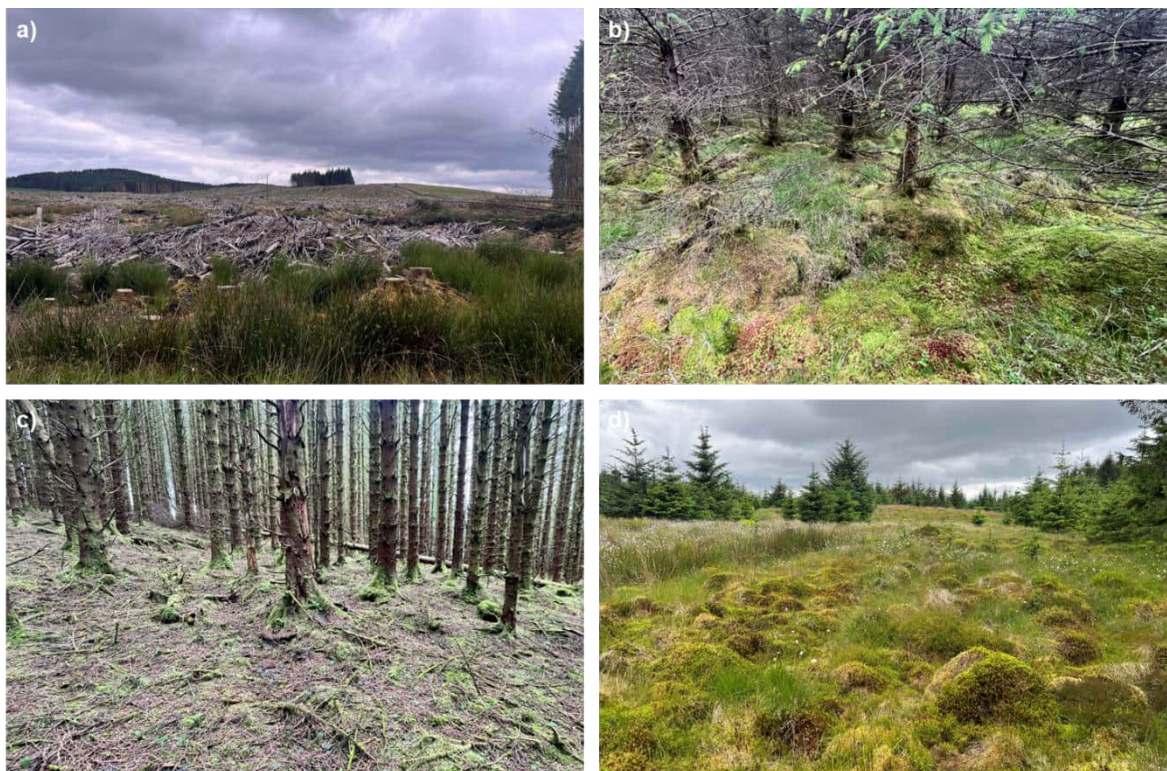
**Plate 3.3 a) Felled plantation forestry, b) better quality habitat under more open forest in an area of checked growth, c) typical understorey conditions in more mature forestry, d) good quality habitat in forest ride**

Land use is primarily commercial forestry. Conditions within the forestry are shown on Plates 3.3a to d. Given the relatively limited peat depths across the Site (see section 3.5), vegetation under the canopy is limited, with ample needles and bare ground. The best habitats are found within rides and glades or in larger open areas.
