## **Preliminary Borrow Pit**

**SHEPHERDS' RIG WIND FARM  
PRELIMINARY BORROW PIT ASSESSMENT**

**VERSION 3.0**

**OCTOBER 2018**

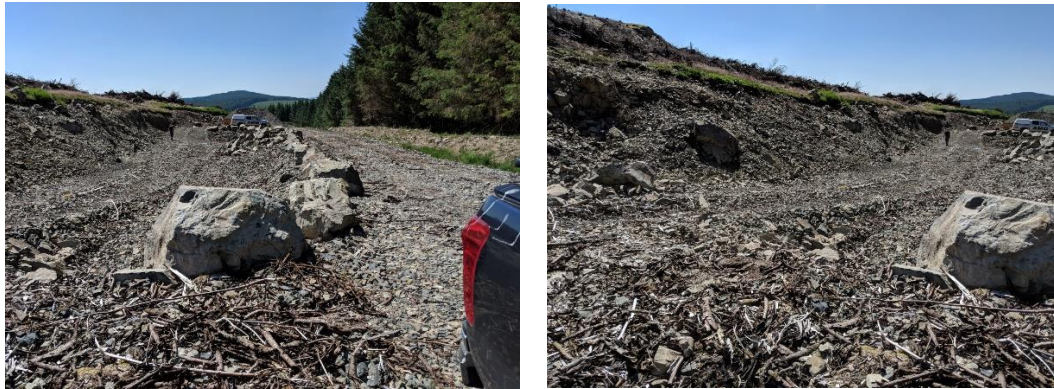
Borrow Pit 1 is located at the south-western side of Craigengillan, approximate centre point BNG 262109, 595388. The site was selected due to being adjacent to existing tracks and the evidence of recent quarrying activities associated with forestry access works.

BGS superficial soils information indicates that this area of the Development is primarily vacant of any significant superficial soil cover, although areas of till and peat were recorded to the immediate west. Peat probing undertaken recorded depths of 0.1m only in the general vicinity of this borrow pit search area. The solid geology mapping indicates the underlying bedrock to be primarily Ordovician aged Portpatrick Wacke belonging to the Scaur Group and consisting of massive thick-bedded turbidites of which the Sandstones are rich in andesitic detritus. A fairly significant late Silurian to early Devonian aged intrusion was present, orientated north-east to south-west across this part of the site. No geological faulting is present within the borrow pit search area or immediate vicinity. The location does not encroach any other environmental development constraints.

***Figures 3.1 and 3.2 - Existing conditions at Borrow Pit Search Area 1***

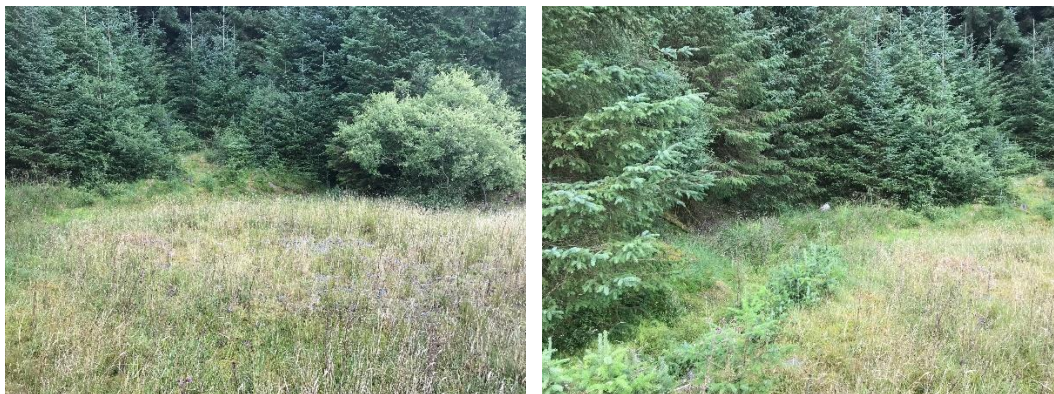
Borrow Pit 2 is located east of Furmiston Craig, centrally located within the southern portion of the site, at approximate centre point BNG 262142, 593572. The site was selected due to its proximity to existing tracks and the indication of previous quarrying activities from Ordnance Survey mapping. It was obvious after the site visit that the previous quarrying activities were historic and very localised and the area between was heavily overgrown with mature vegetation and forestry.

BGS superficial soils information indicates that this area of the Development is primarily vacant of any significant superficial soil cover, although areas of till and peat were recorded to the east and west respectively. Peat probing undertaken recorded depths of less than 0.5m in the general vicinity of this borrow pit search area. The solid geology mapping indicates the underlying bedrock to be Ordovician aged Portpatrick Wacke belonging to the Scaur Group and consisting of massive thick-bedded turbidites of which the Sandstones are rich in andesitic detritus. No geological faulting is present within the borrow pit search area or immediate vicinity. The location also does not encroach any other environmental development constraints.

***Figures 3.3 and 3.4 - Existing conditions at Borrow Pit Search Area 2***

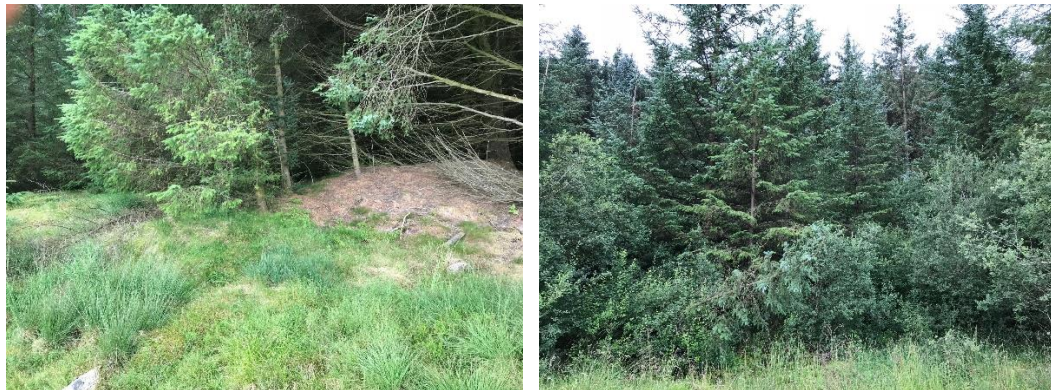
Borrow Pit 3 is located at the north-eastern side of Marscalloch Hill, approximate centre point BNG 261879, 592536. The site was selected due to being adjacent to existing tracks and the indication of previous quarrying activities from Ordnance Survey mapping. It was obvious after the site visit that the historical quarrying activities were fairly localised and the area was heavily overgrown with mature vegetation and forestry. However, beyond the peripheral vegetation, the topographic gradient steeply rose towards the south-west.

BGS superficial soils information indicates that this area of the Development is vacant of any significant superficial soil cover. Peat in the general vicinity of this borrow pit search area was generally less than 0.5m. The solid geology mapping indicates the underlying bedrock to be Ordovician aged Portpatrick Wacke belonging to the Scaur Group and consisting of massive thick-bedded turbidites and the Sandstones are rich in andesitic detritus. No geological faulting is present within the borrow pit search area or immediate vicinity. The location also does not encroach any other environmental development constraints.

***Figures 3.5 and 3.6- Existing conditions at Borrow Pit Search Area 3***

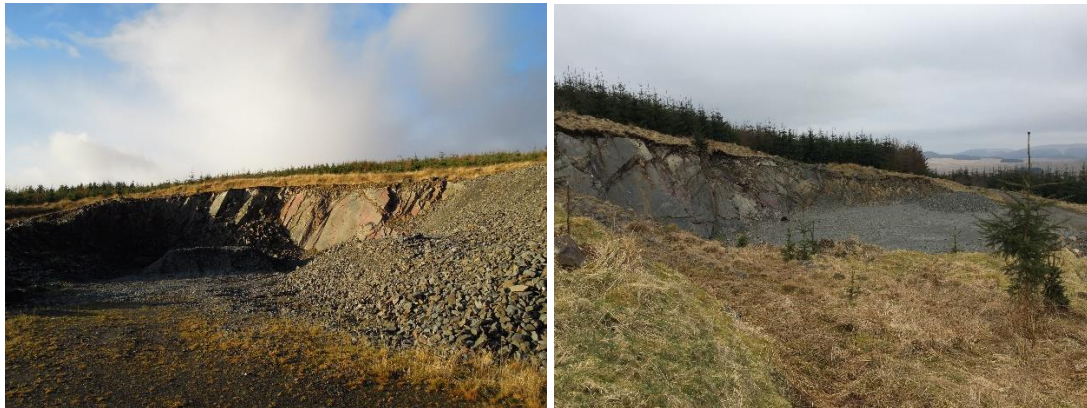
Borrow Pit 4 is located at the south-eastern side of Marscalloch, approximate centre point BNG 261799, 591,855. The site was selected due to being adjacent to existing tracks and the evidence of previous quarrying activities.

BGS superficial soils information indicates that this area of the Development is primarily vacant of any significant superficial soil cover, although areas of till and peat were recorded to the immediate west. Peat probing undertaken recorded depths of less than 0.5m in the general vicinity of this borrow pit search area. The solid geology mapping indicates the underlying bedrock to be Ordovician aged Portpatrick Wacke belonging to the Scaur Group and consisting of massive thick-bedded turbidites and the Sandstones are rich in andesitic detritus. No geological faulting is present within the borrow pit search area or immediate vicinity. The location also does not encroach any other environmental development constraints.

**Figures 3.7 and 3.8 - Existing conditions at Borrow Pit Search Area 4**

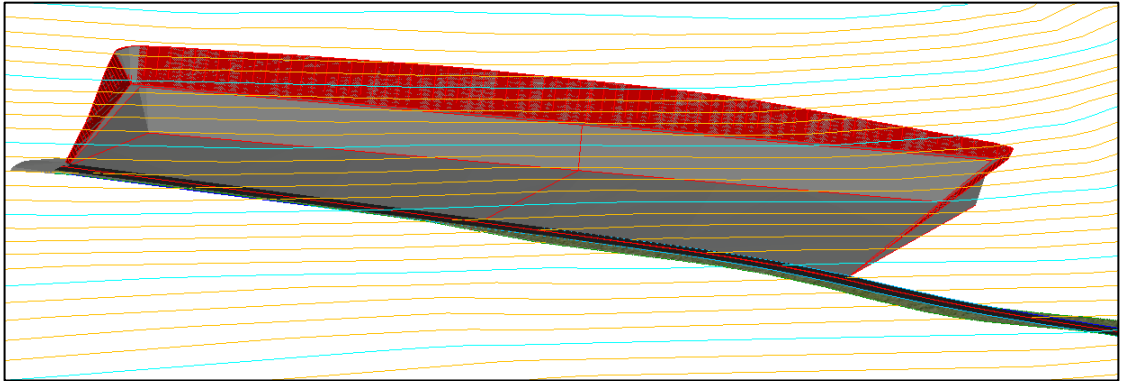
- Borrow Working 1 area of approximately 145 m x 60m;
- Borrow Working 2 area of approximately 125 m x 85 m;

- Borrow Working floor levels taken from the levels associated with the existing access track; and
- Cut profile at 63° from borrow pit floor to 1st tier, followed by 2.0m wide benching and 63° from benching to intersection point of existing terrain.

Figures 3.9 and 3.10 below illustrate an isometric view of the borrow working design.

***Figure 3.9 – Three-Dimensional Model Borrow Working 1 Facing North-East***

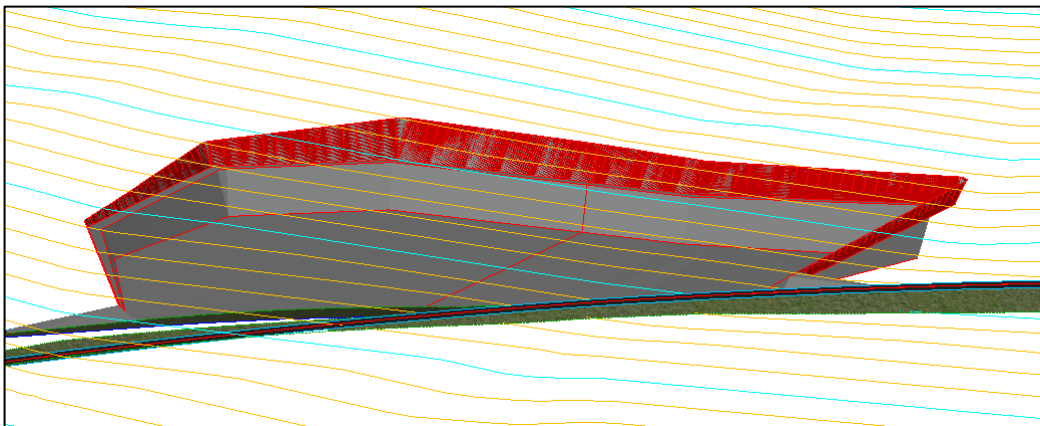
***Figure 3.10 – Three-Dimensional Model Borrow Working Two Facing West***

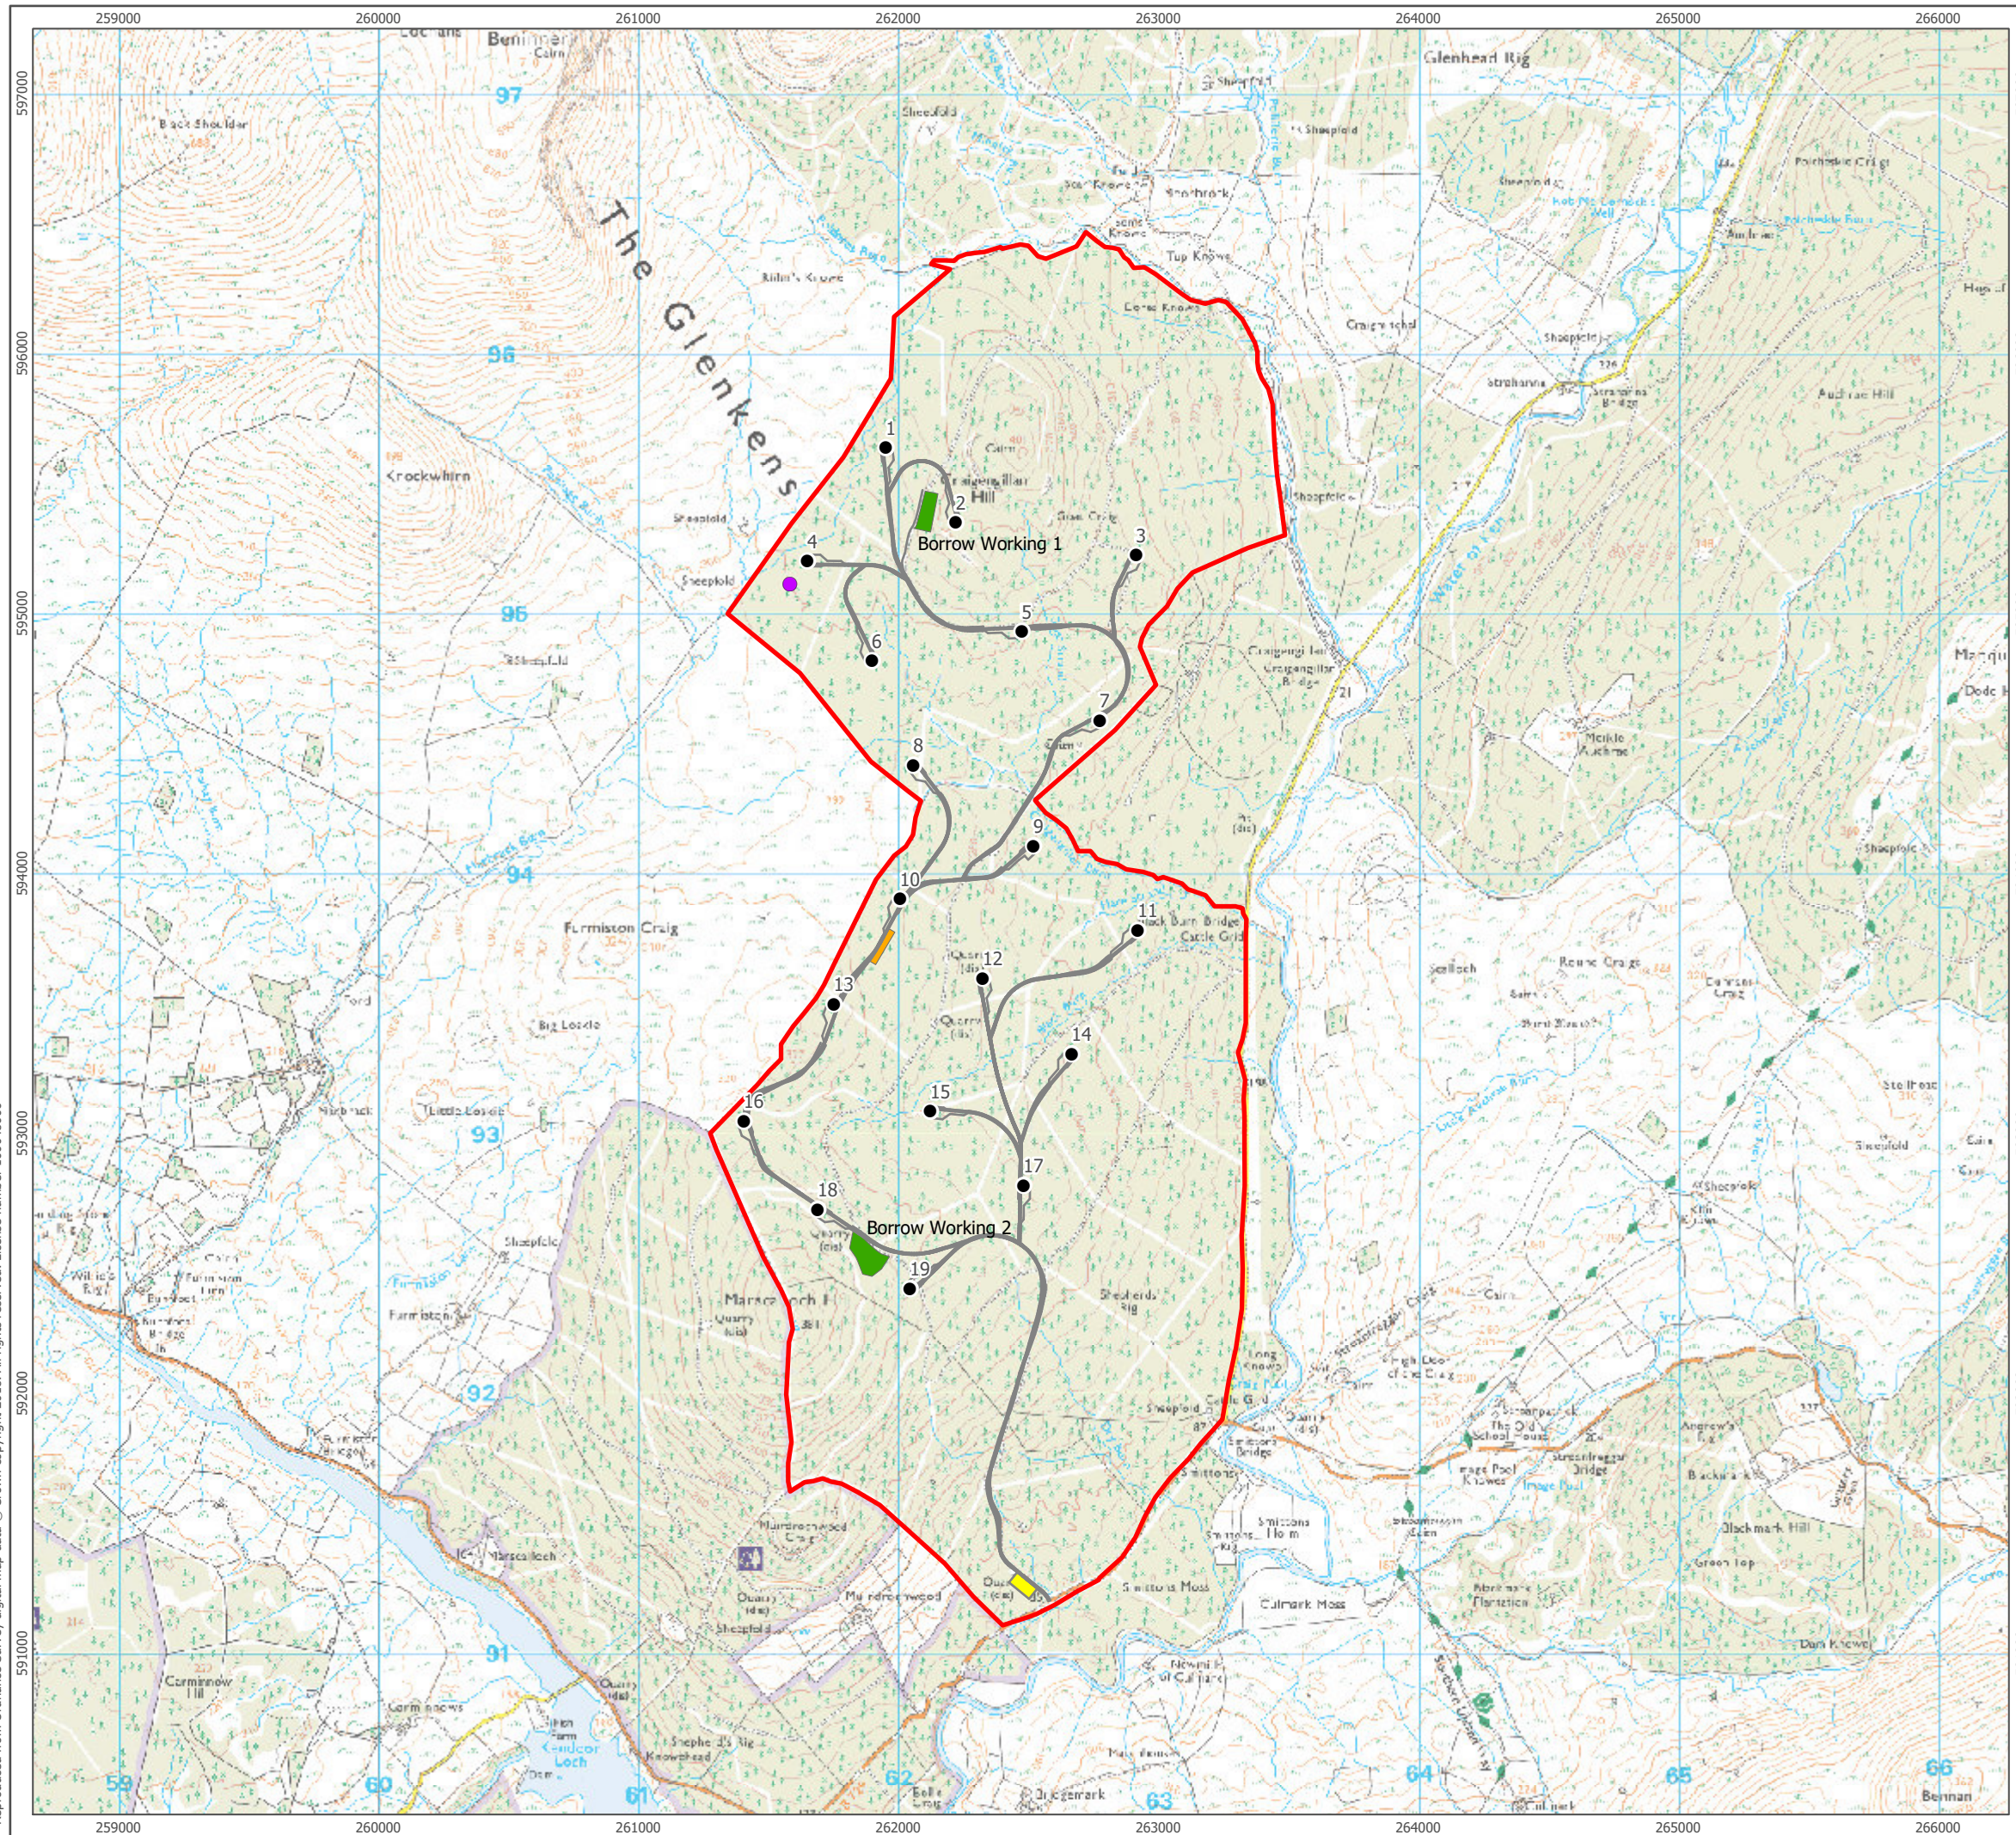
Proposed Site Layout  
Figure 1

The Development occupies an area of forestry and open hillside located to the north-west of the B729. The access road rises from approximately British National Grid (BNG) 262578, 591206 continuing north through forestry on the eastern side of Marscalloch Hill before sweeping towards the western side Cragengillan Hill. Figure 1, 'Proposed Site Layout' is included in Appendix A.

The proposed development includes a mix of new and existing track upgrade, nineteen turbines, a control room/substation, site compound and met-mast.

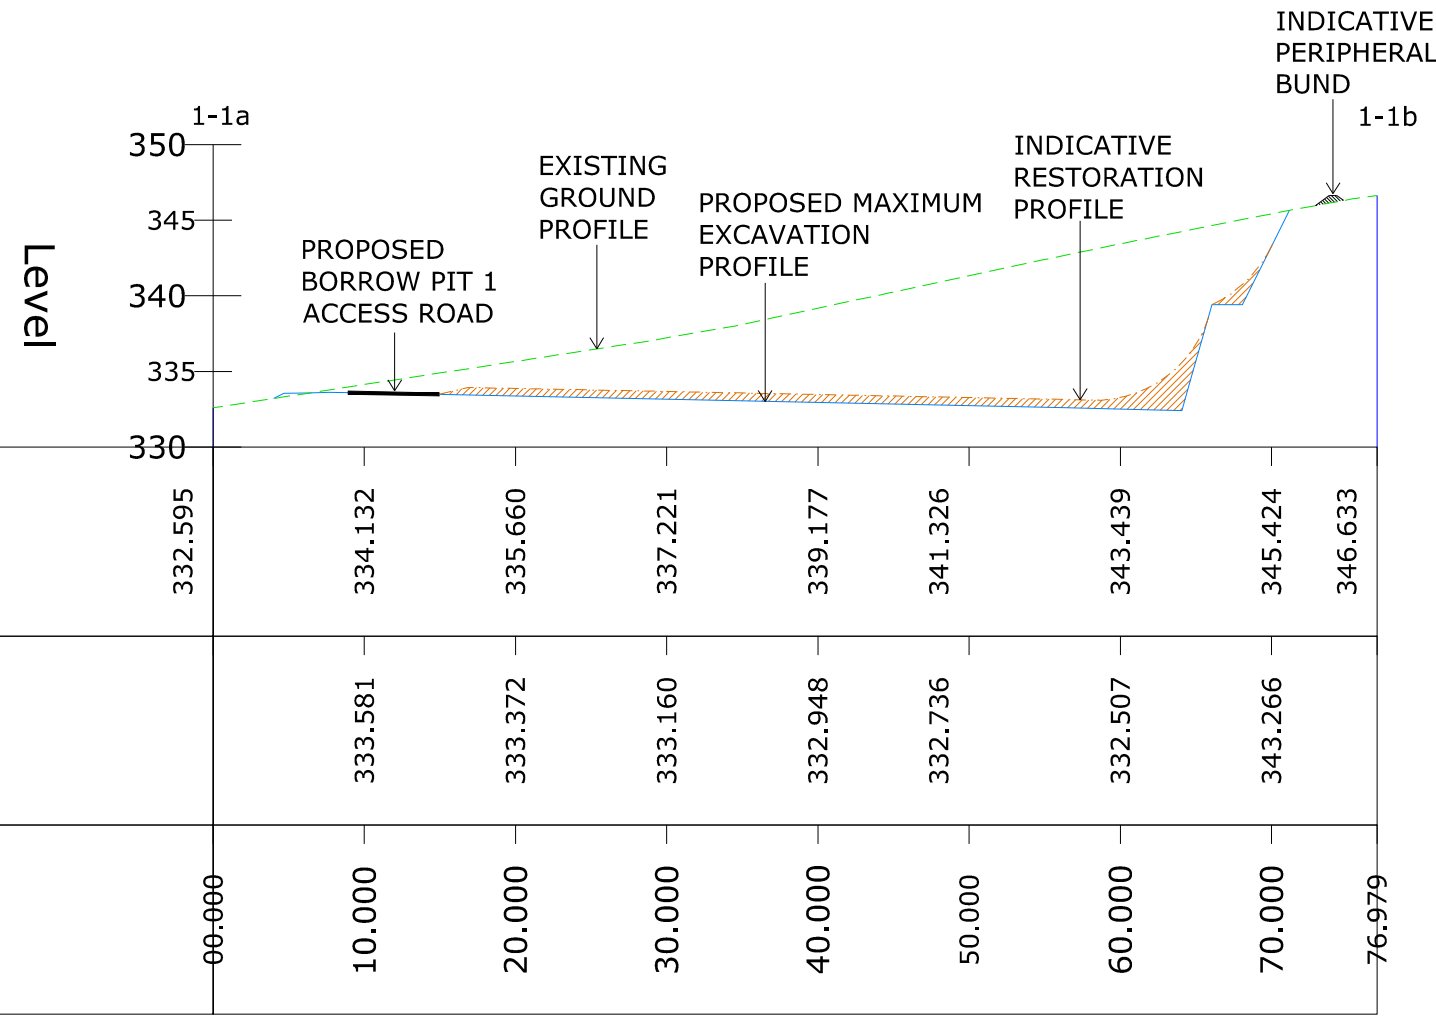
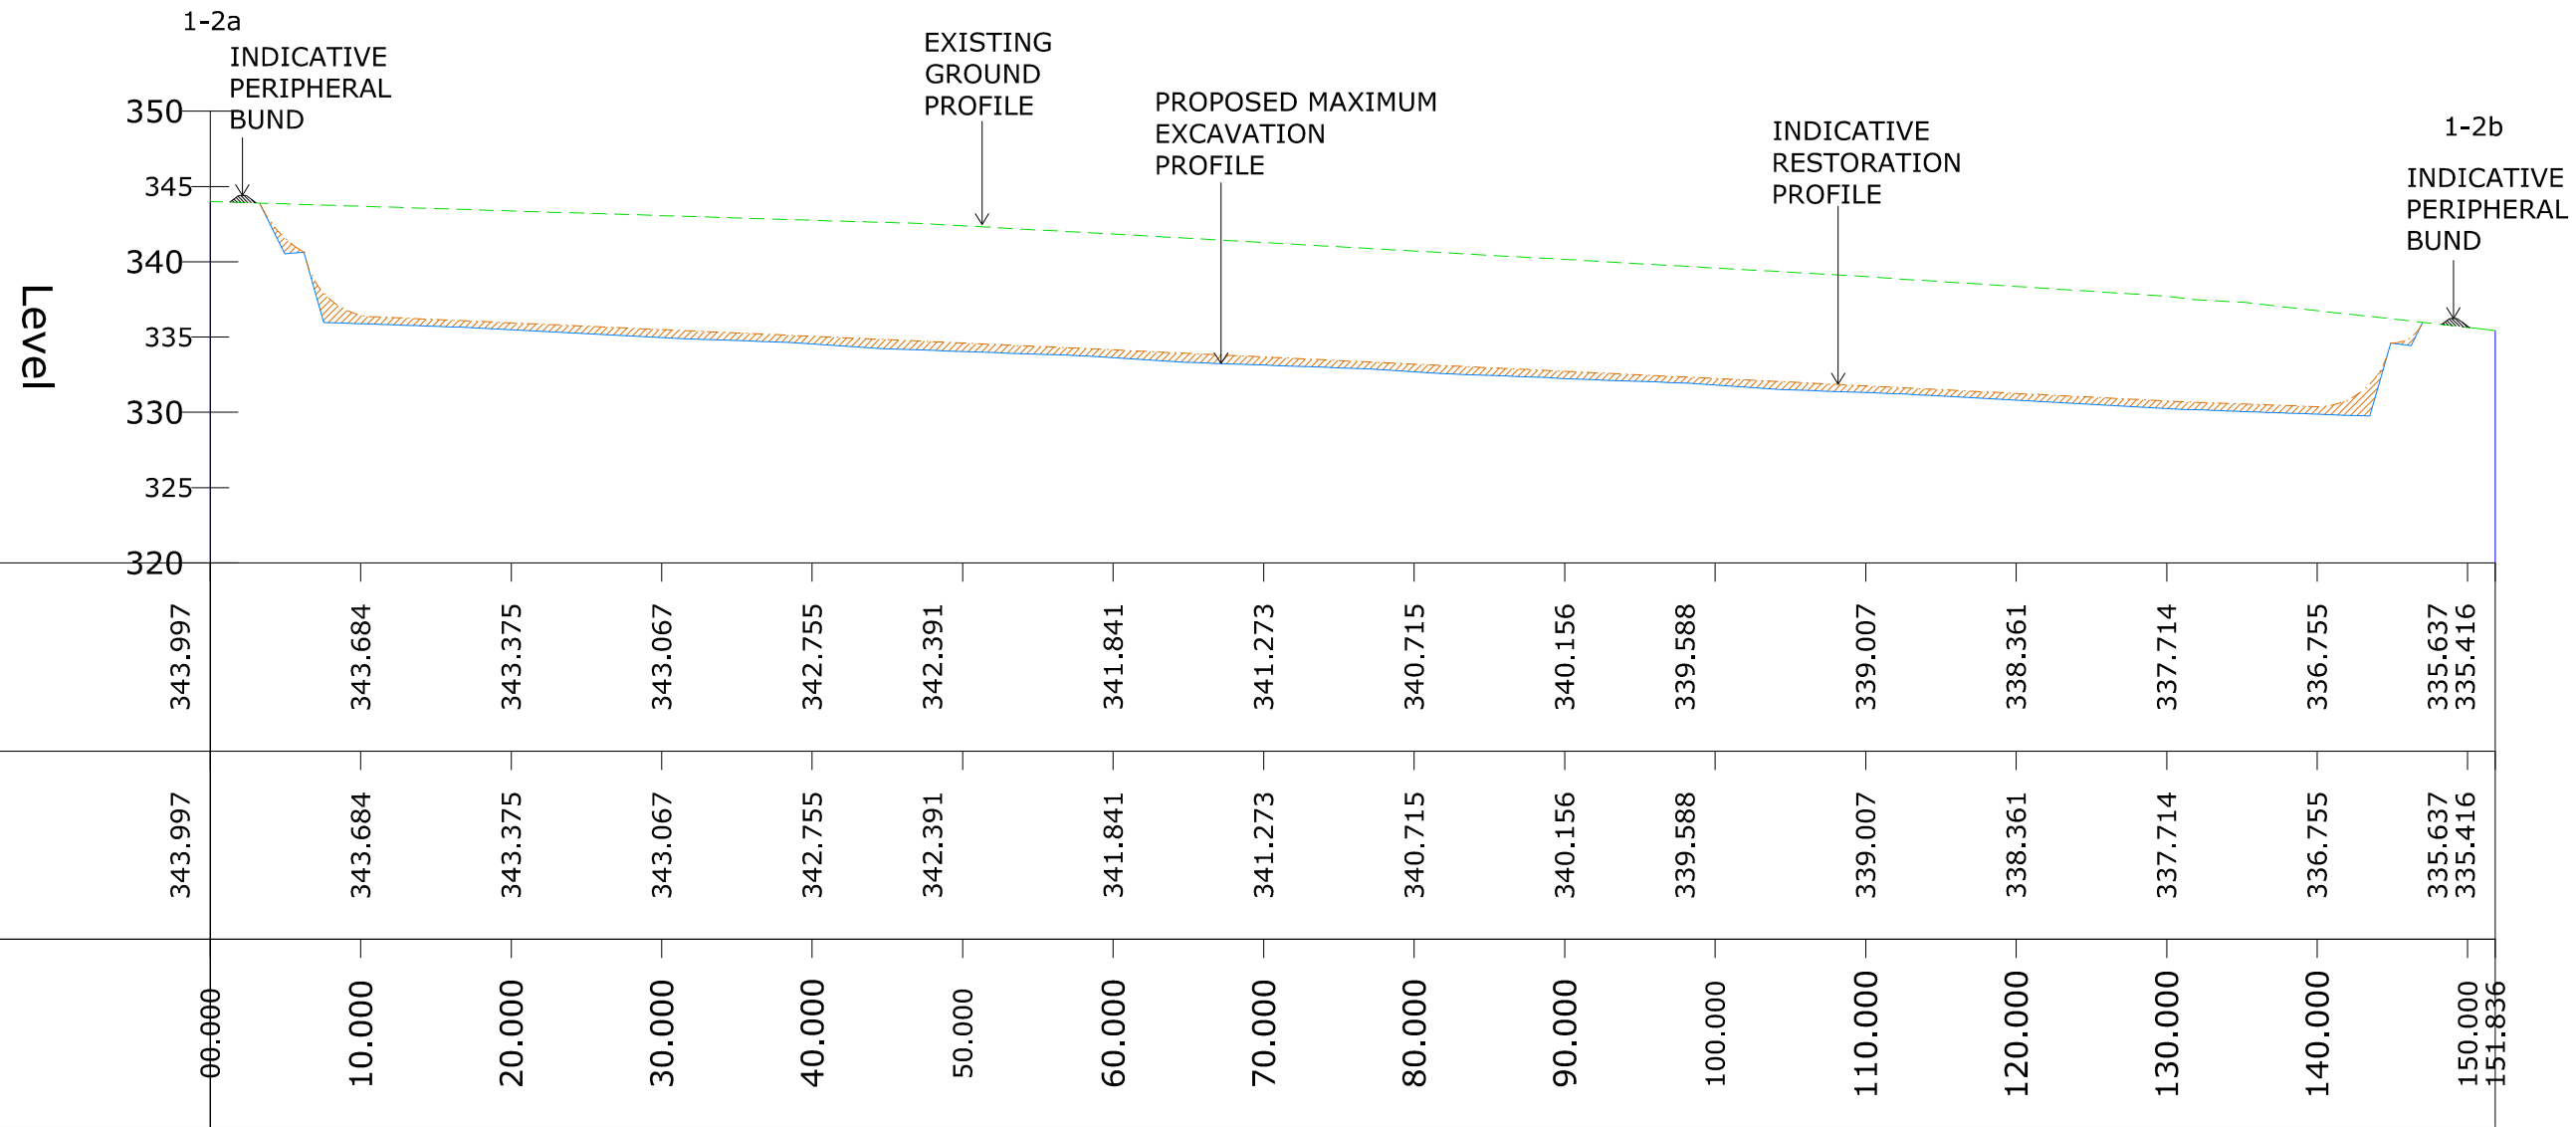
BORROW WORKING 1 PROFILES  
SCALE - 1:500

Based on the identified search areas, a three-dimensional outline design was undertaken to establish the target capacity required from the proposed borrow pits. This involved a civil design taking account of the overall proposed site layout levels and both existing and proposed access tracks in order to develop a viable borrow area. The outline design of each borrow working included a main worked area with earthwork batters and indicative drainage cut-off ditches, and therefore was finalised as a total area situated within the initial search areas. The details of the outline borrow working design is summarised in Table 3.1 below while Borrow Working Plans and Profiles are shown in Figure 2 in Appendix A.

ALIGNMENT - BP1-1  
SCALE: H 1:500,V 1:500. DATUM: 330.000

ALIGNMENT - BP1-2  
SCALE: H 1:500,V 1:500. DATUM: 320.000

The conjectured reinstatement profiles are shown in Figure 2 in Appendix A.

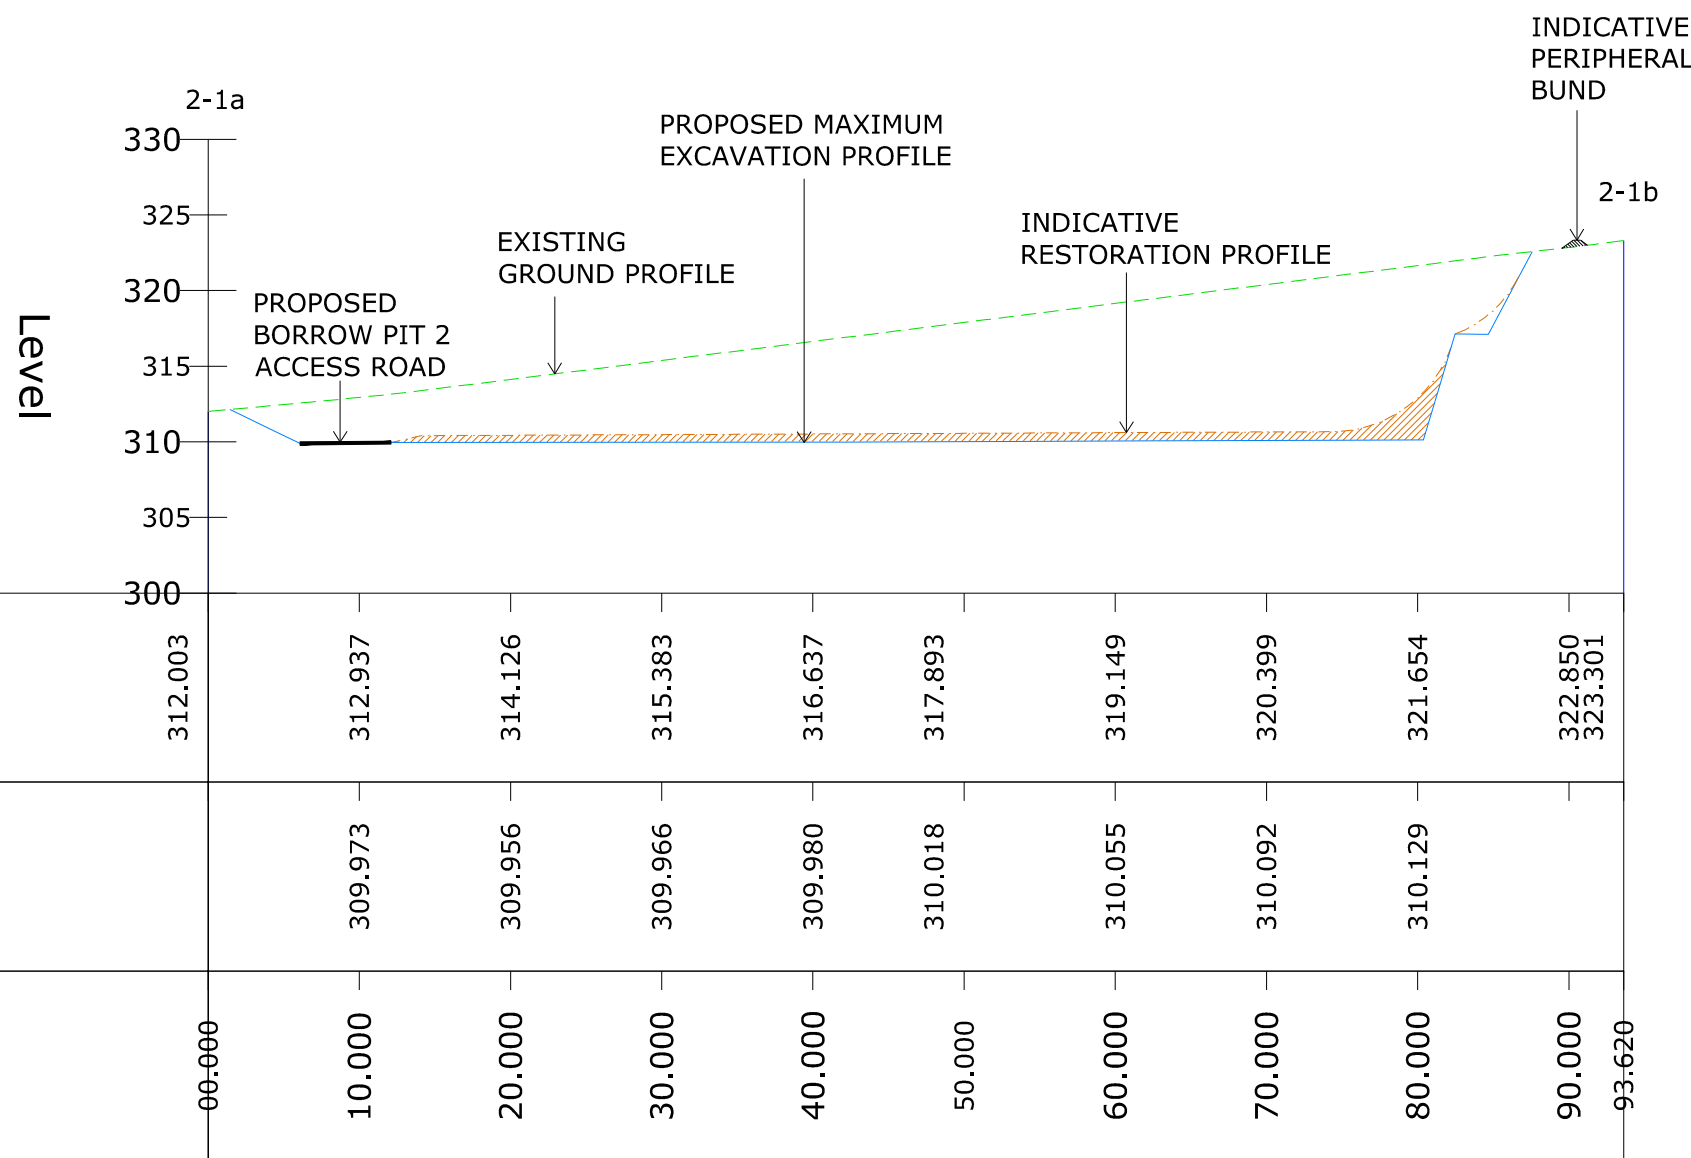
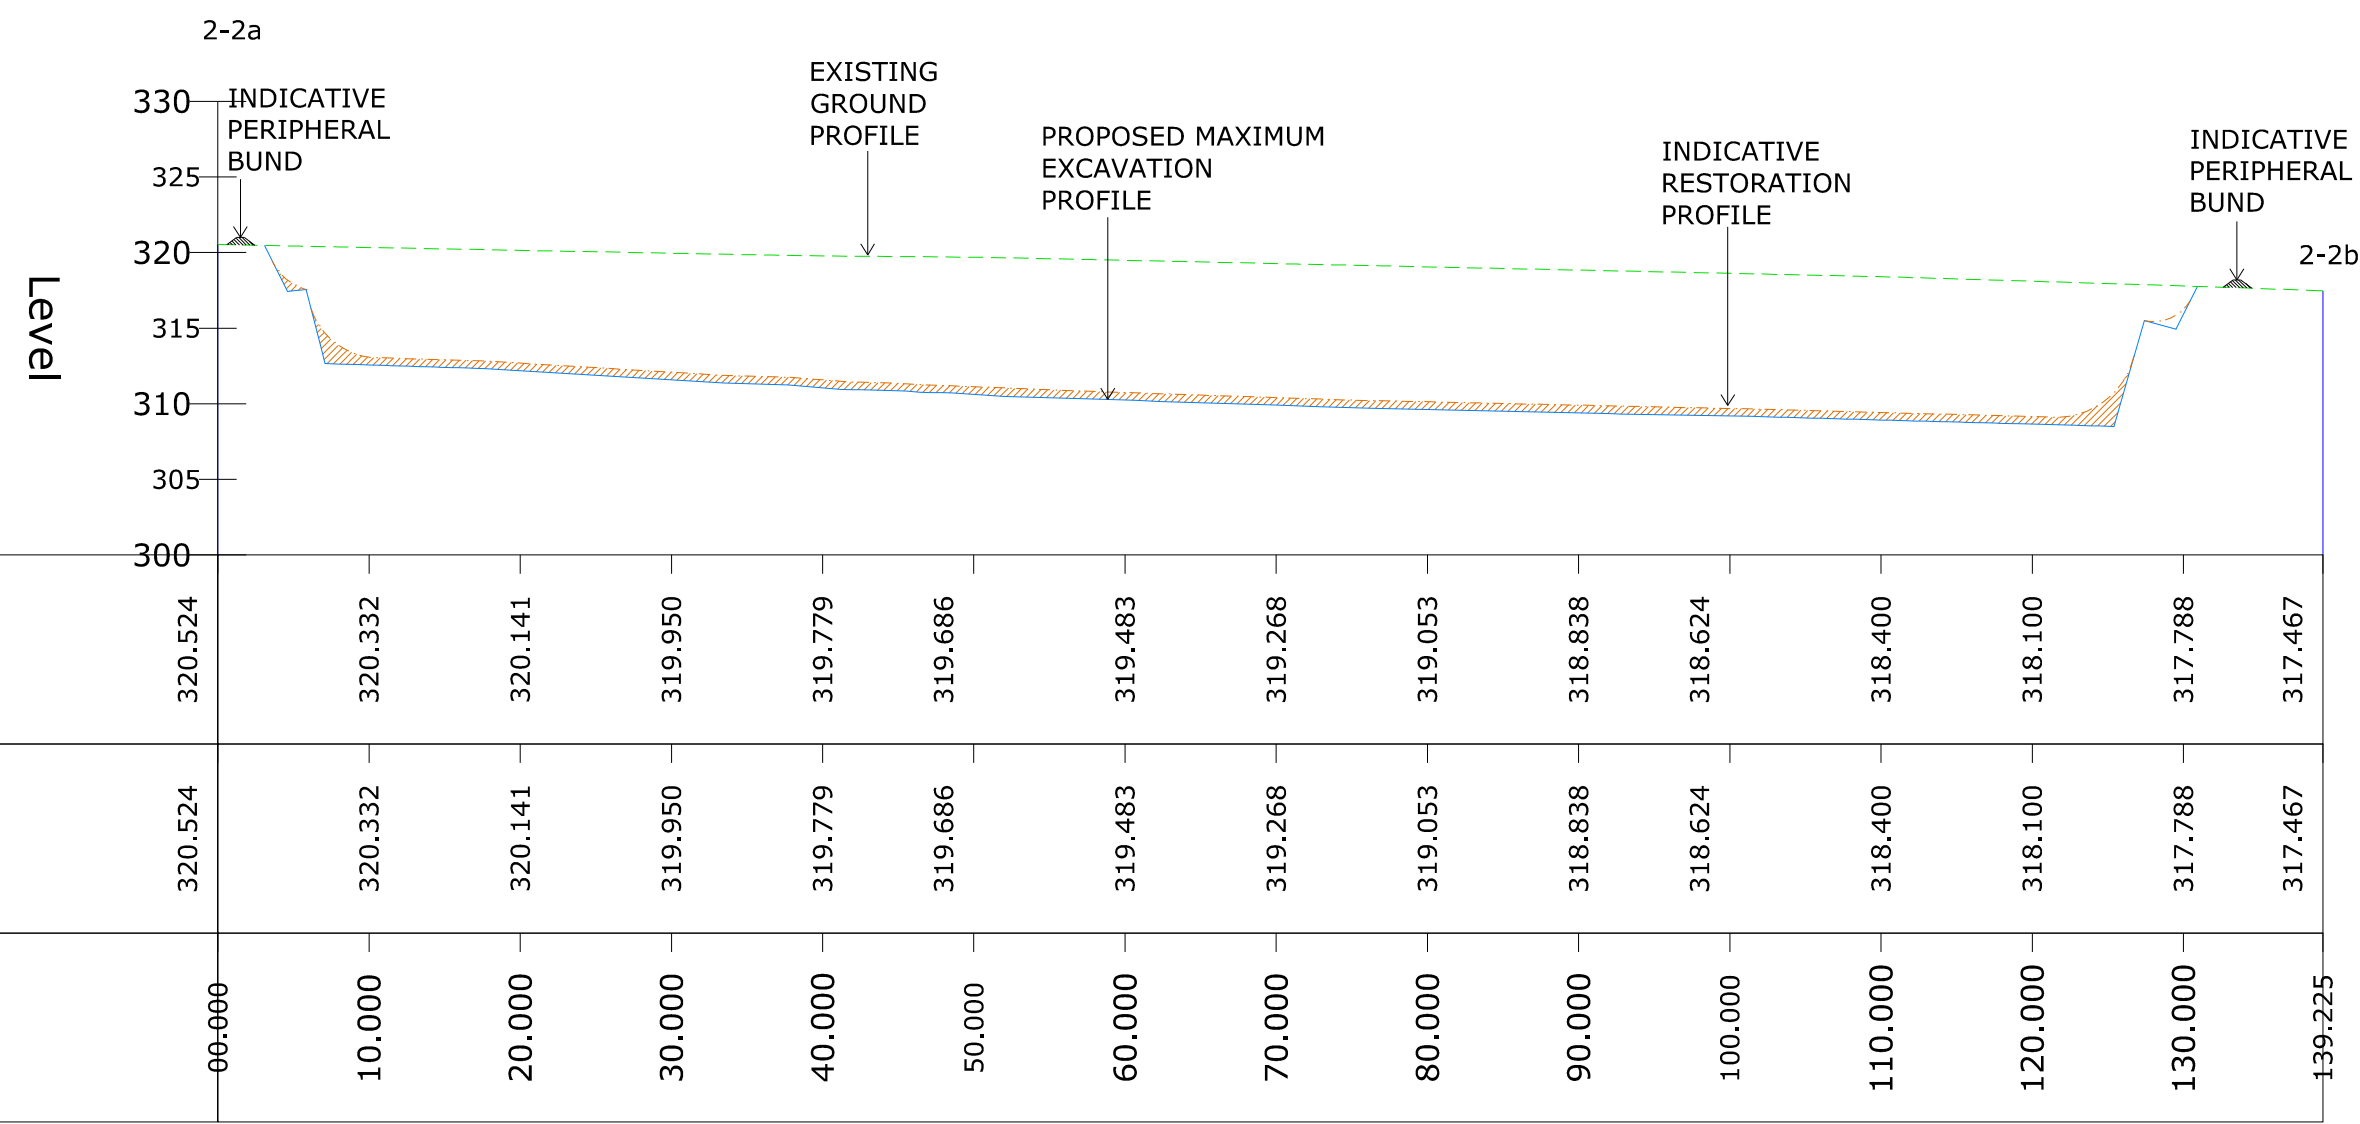
BORROW WORKING 2 PROFILES  
SCALE - 1:500

ALIGNMENT - BP2-1  
SCALE: H 1:500,V 1:500. DATUM: 300.000

ALIGNMENT - BP2-2  
SCALE: H 1:500,V 1:500. DATUM: 300.000

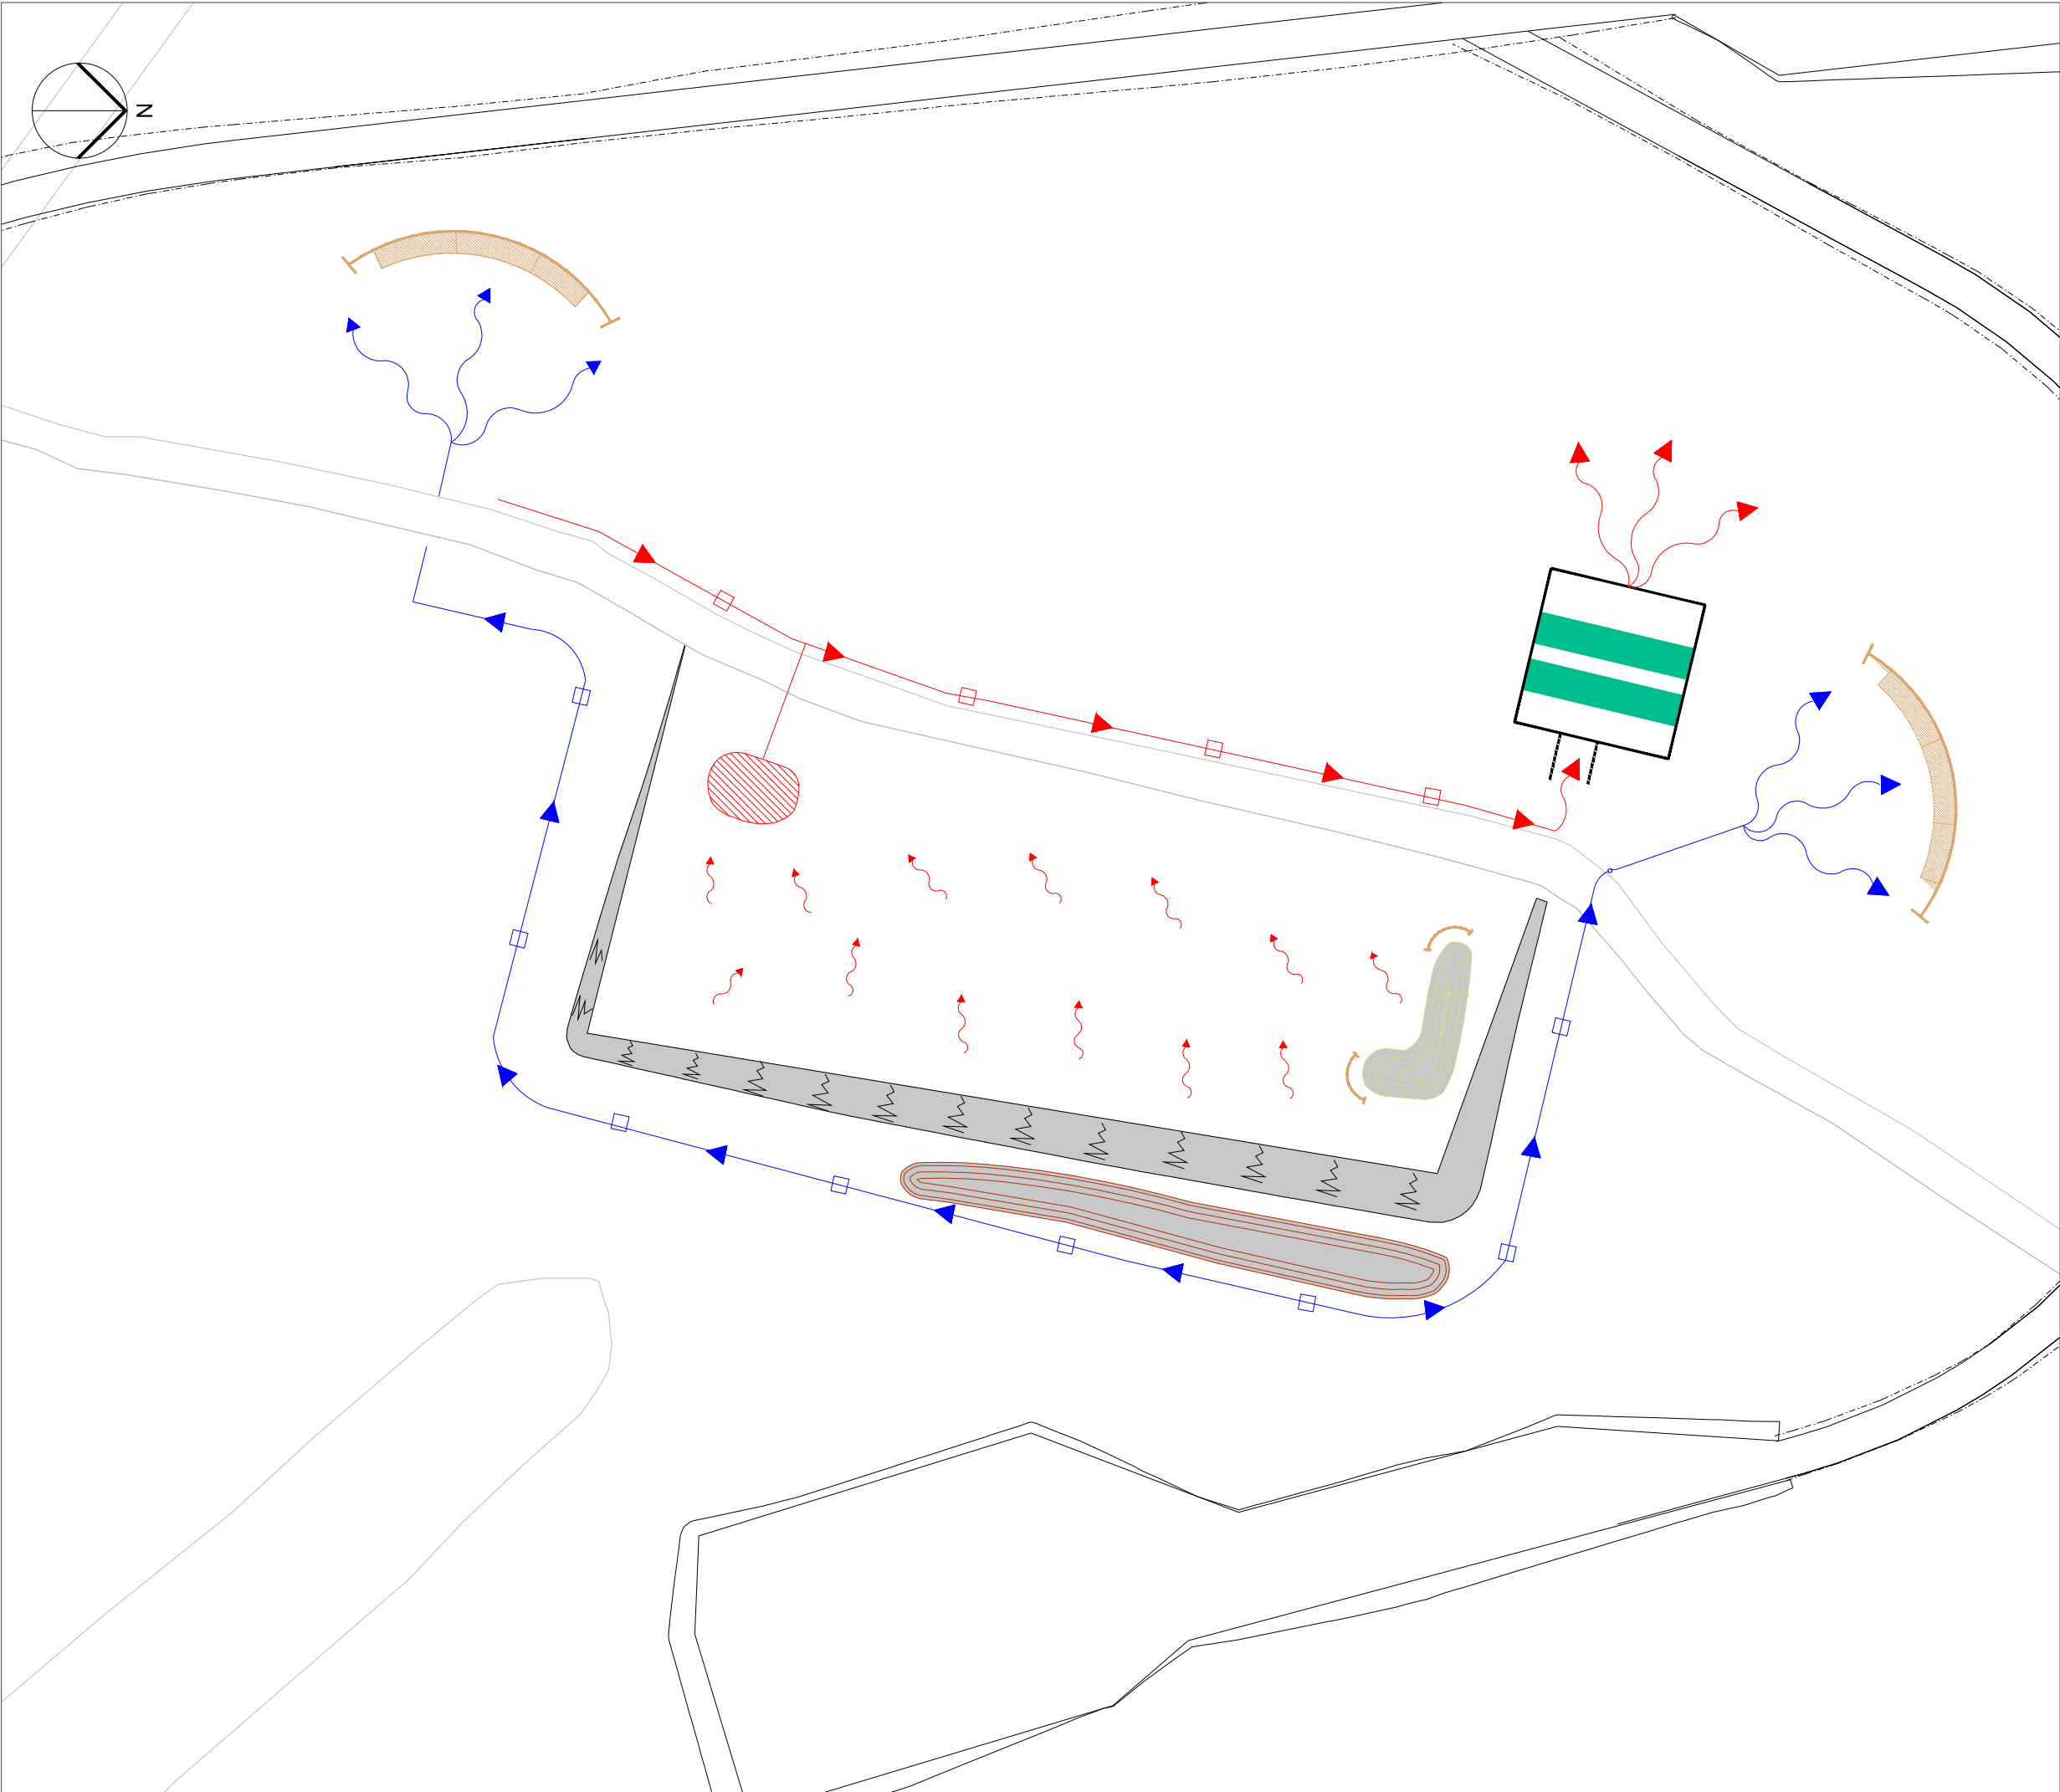
Temporary interception/peripheral bunds and cut-off drainage ditches ('clean water drains') should be constructed upslope of the borrow pits and cuts to prevent surface water runoff entering the excavation. Swales to collect runoff should be placed on the downslope of borrow pits and overburden / stockpiles and will be designed to treat potentially silty runoff before discharging back into the drainage system.

A drainage and surface water management system will be required in order to control surface water run-off from borrow pit areas. Due to the nature and size of the proposed excavations, the drainage system should comprise of a peripheral cut-off ditch together with attenuation features and soakaways. Drainage ditches should be installed using a tracked excavator and, where necessary, a hydraulic breaker.

**Borrow Working 1**  
**Schematic Drainage Plan**  
Figure 4

Figure 3 and 4 indicates a schematic drainage plan for each borrow pit and is provided in Appendix A.
