## **Preliminary Borrow Pit**

**SHEPHERDS' RIG WIND FARM  
PRELIMINARY BORROW PIT ASSESSMENT**

**VERSION 3.0**

**OCTOBER 2018**

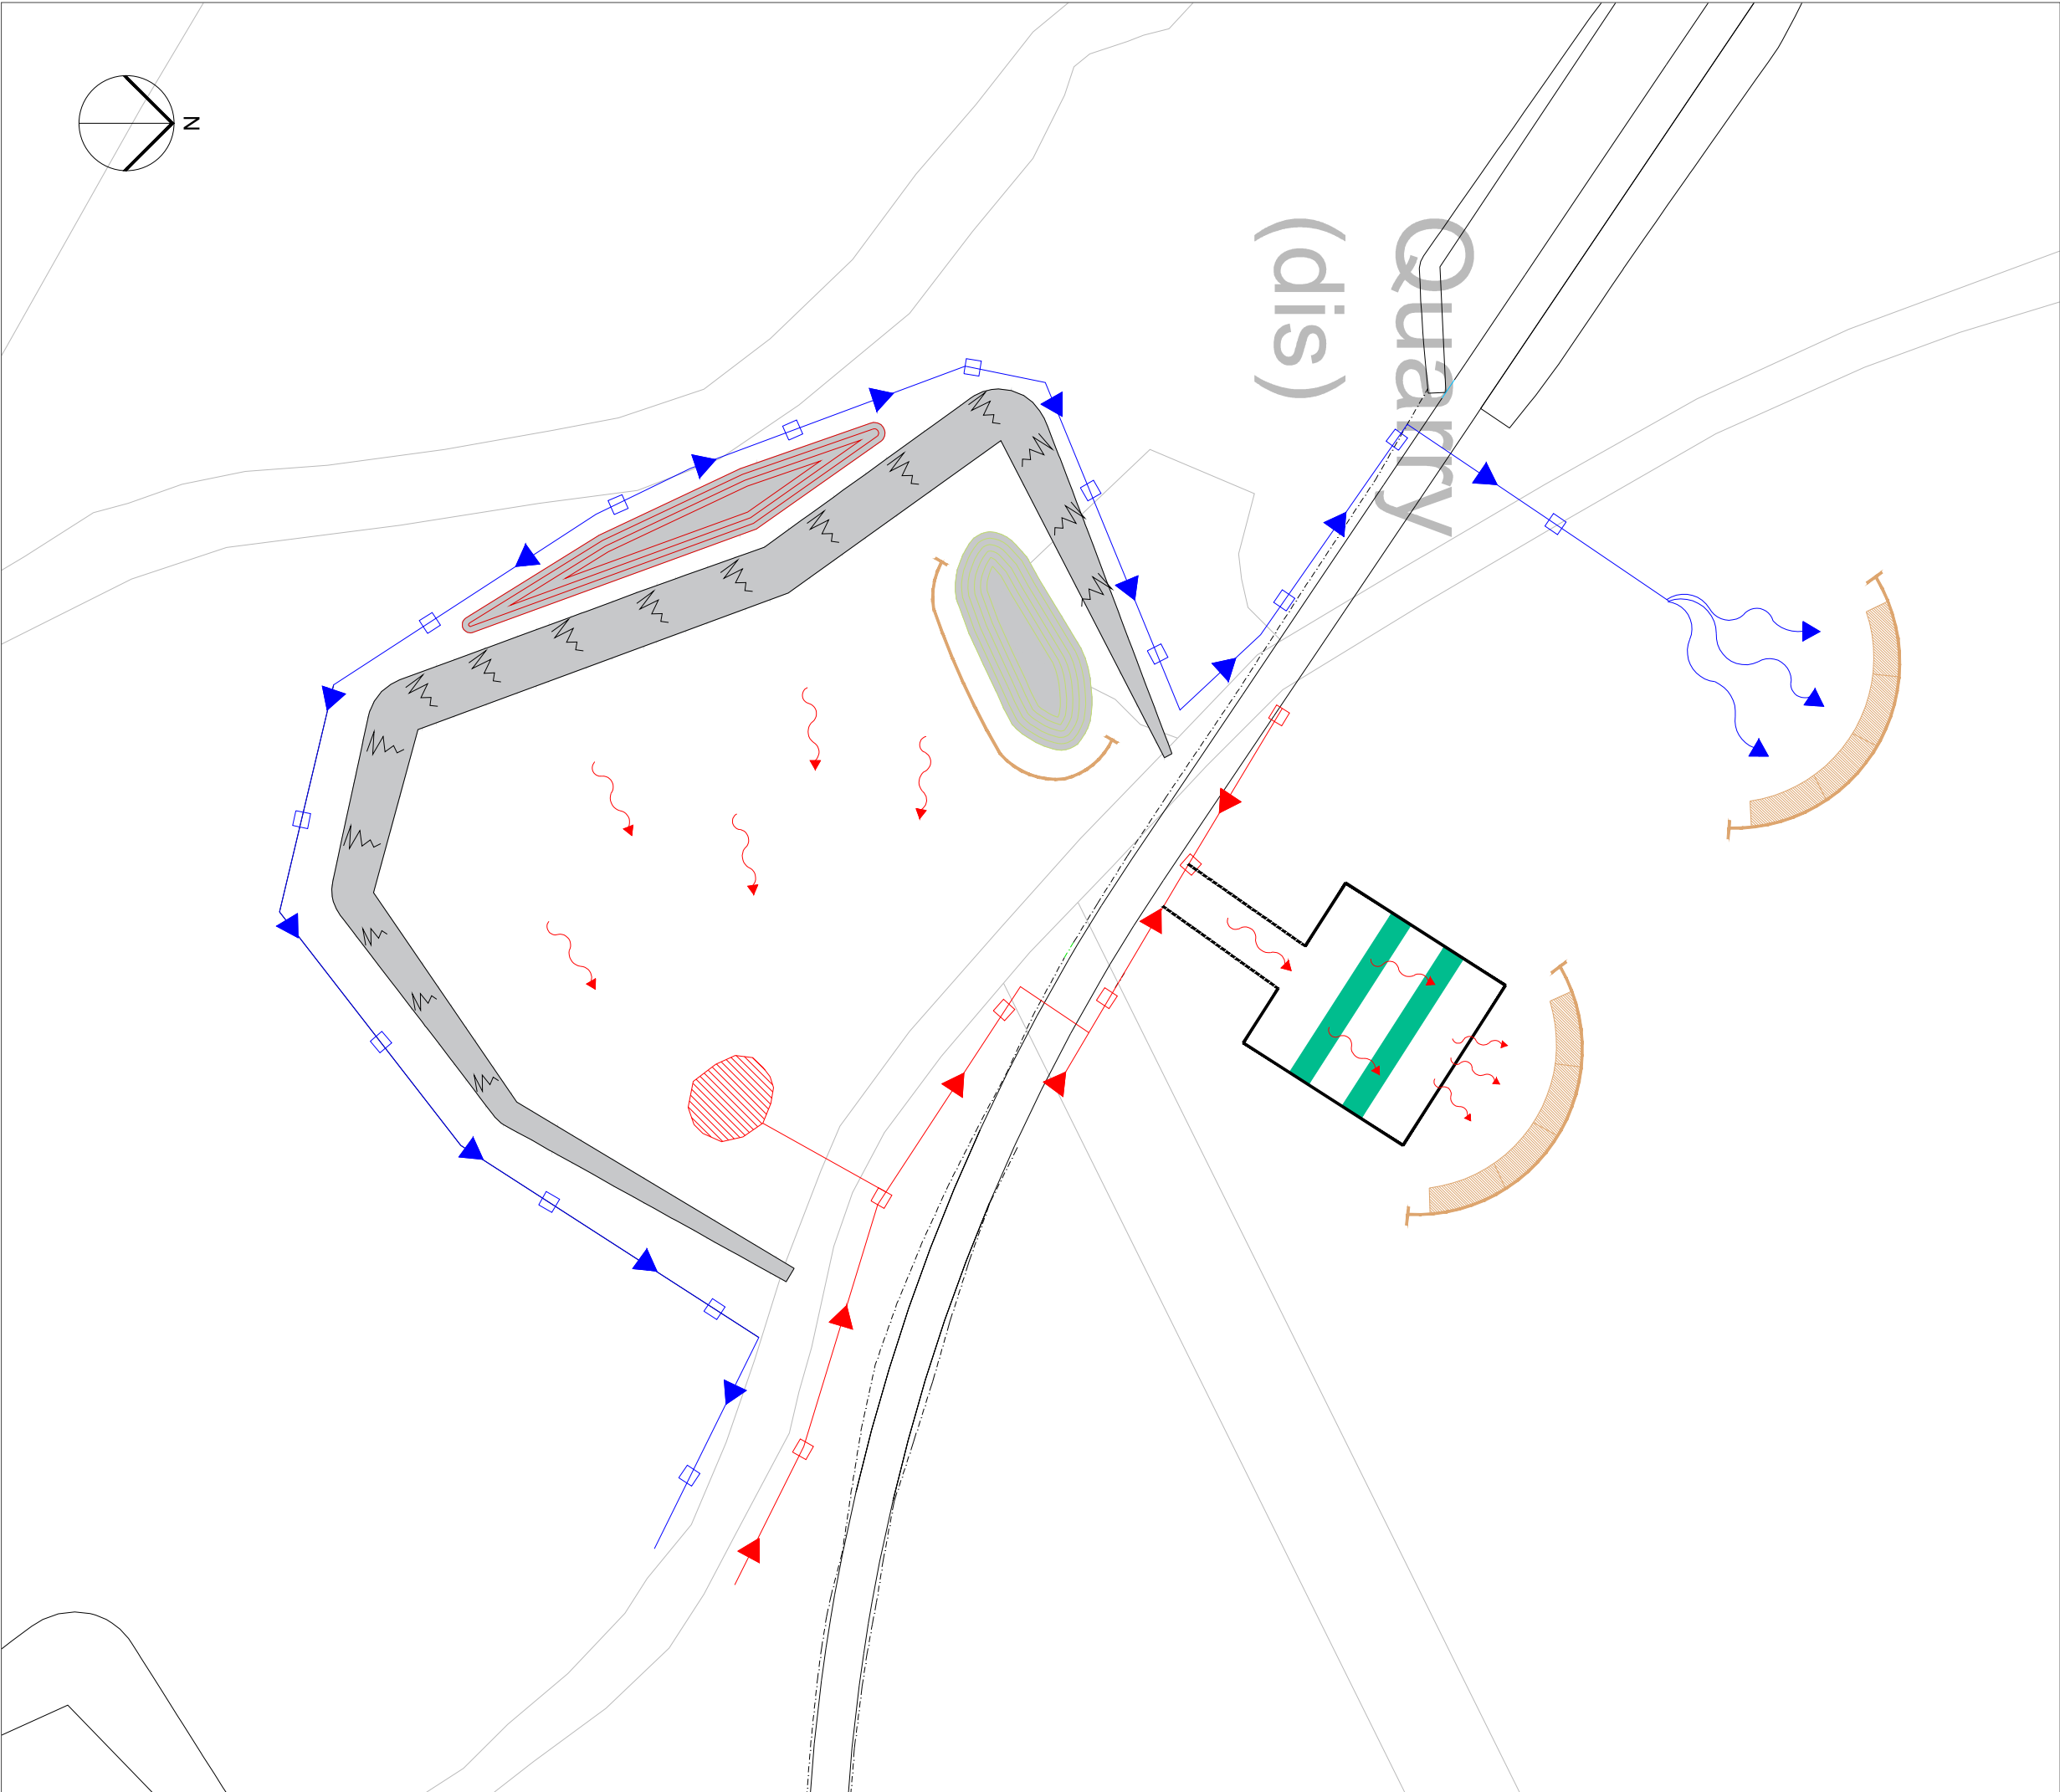
Temporary interception/peripheral bunds and cut-off drainage ditches ('clean water drains') should be constructed upslope of the borrow pits and cuts to prevent surface water runoff entering the excavation. Swales to collect runoff should be placed on the downslope of borrow pits and overburden / stockpiles and will be designed to treat potentially silty runoff before discharging back into the drainage system.

A drainage and surface water management system will be required in order to control surface water run-off from borrow pit areas. Due to the nature and size of the proposed excavations, the drainage system should comprise of a peripheral cut-off ditch together with attenuation features and soakaways. Drainage ditches should be installed using a tracked excavator and, where necessary, a hydraulic breaker.

**Borrow Working 2**  
**Schematic Drainage Plan**  
Figure 5

Figure 3 and 4 indicates a schematic drainage plan for each borrow pit and is provided in Appendix A.
